AFRL-RX-WP-TR-2017-0275

**Sub-Task Order 11: High Speed, Substrate Safe Specialty Coating Laser
Stripping: Project: WP-2146**

Alan Fletcher and Michelle Barga

**22 JUNE 2015
FINAL REPORT**

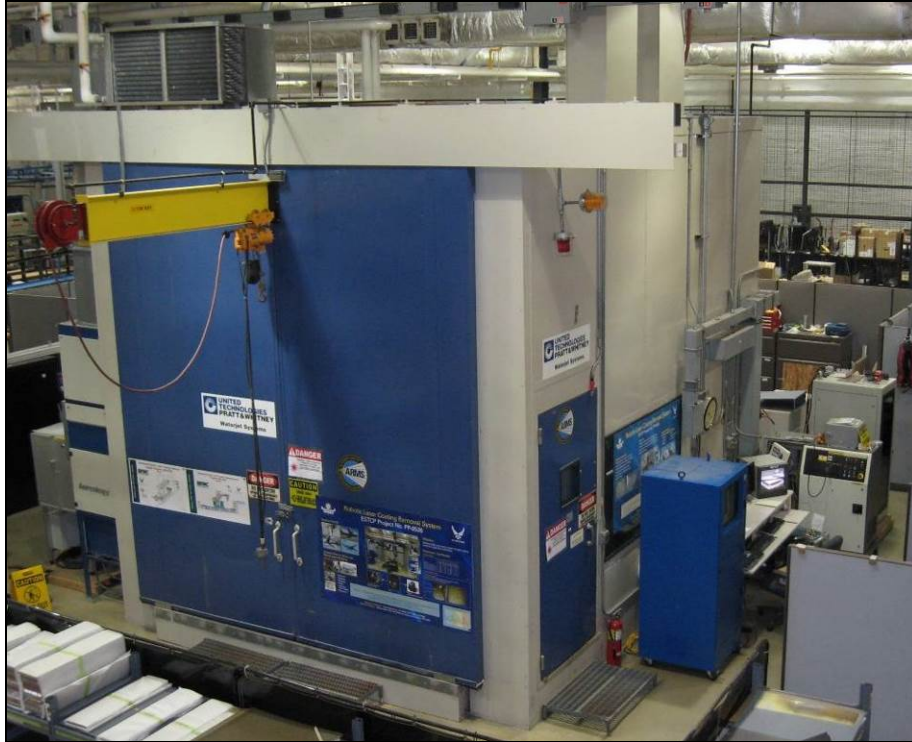
Figure 5. Laser Coating Removal System Test Cell at CTC

This project leveraged and utilized the existing USAF owned fiber laser coating removal system housed in a test cell enclosure, shown in Figure 5, at the CTC Environmental Technology Facility (ETF) in Johnstown, PA.

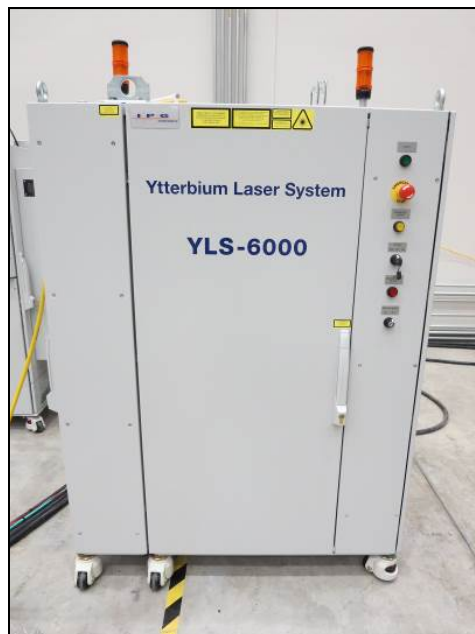
Figure 6. 6 kW Fiber Laser

The fiber laser coating removal system uses a 6 kilowatt (kW) laser system (model: IPG YLR-6000) manufactured by IPG Photonics, Inc, as shown in Figure 6.

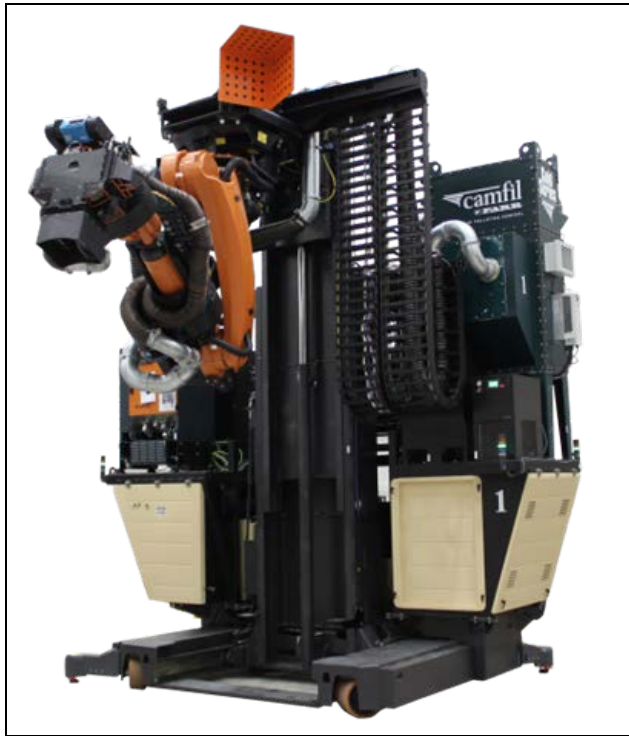
Figure 8. Advanced Robotic Laser Coating Removal System (ARLCRS)

The Full Aircraft ARLCRS, shown in Figure 8, is made of several subsystems that are integrated together into an automated system. The major components include the robotic base, laser, laser process control, and ancillary equipment.

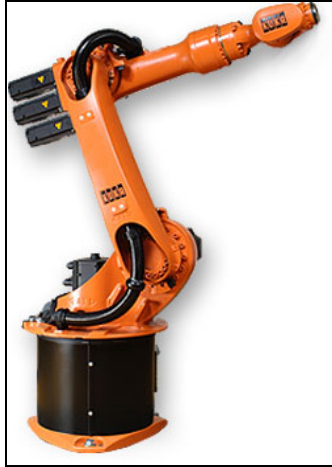
Figure 10. Robotic Arm Manipulator

The next subsystem is the COTS robotic arm manufactured by KUKA an example of which is shown in Figure 10. As part of the detailed system design, a thorough analysis of the reach, mechanics, and control possibilities of multiple commercially available robotic arms was performed prior to selection of KUKA manipulators.

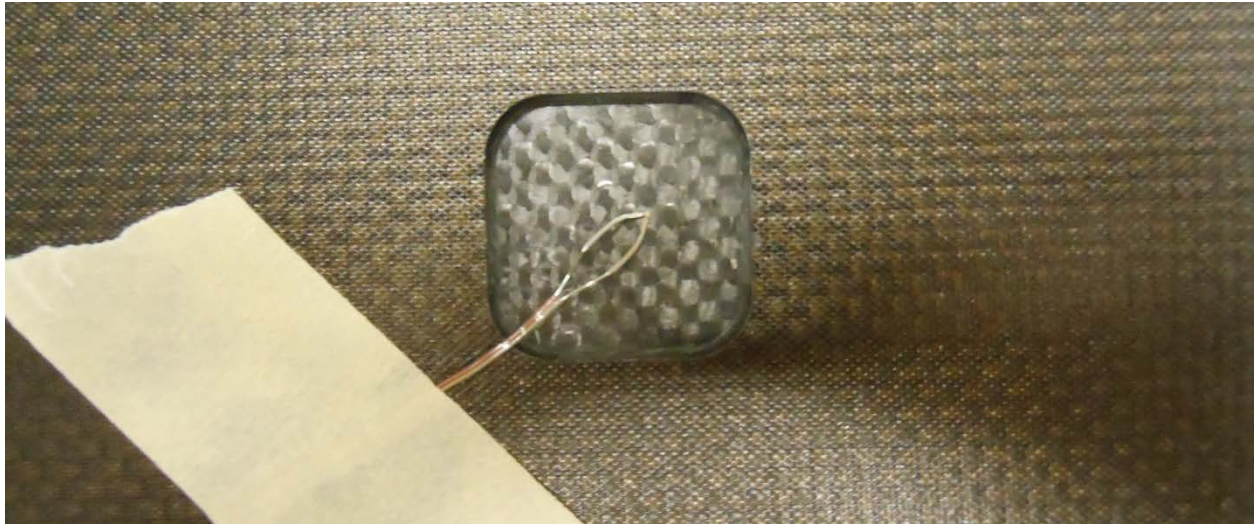
Figure 16. Thermocouple Placement

The thermocouple was bent slightly to ensure that the tip was in direct contact with the bottom of the recess. The lead wire is held in place with masking tape as shown in Figure 16.

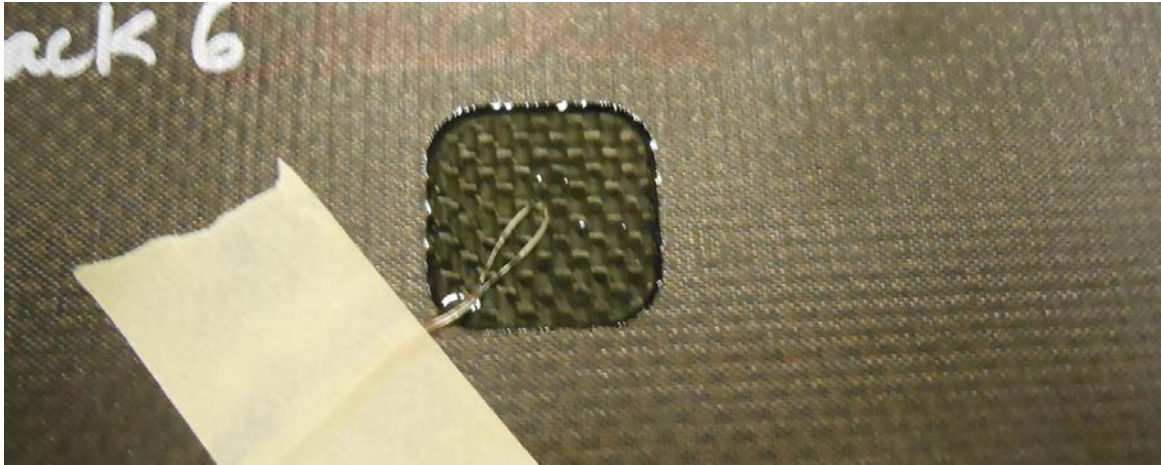
The recesses were filled with 3M Scotch Weld DP 270 clear potting compound, which was the potting compound recommended by AFRL (see Figures 17 and 18).

Figure 17. Potting Compound Installation

Figure 18. Cured Potting Compound

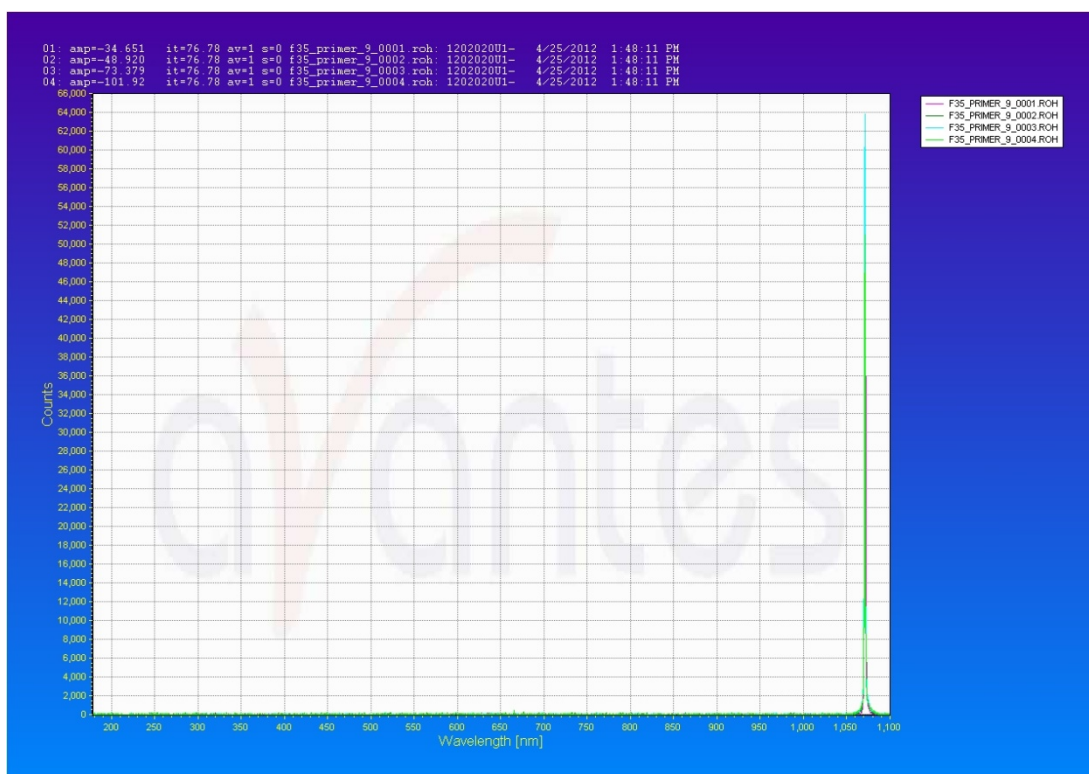
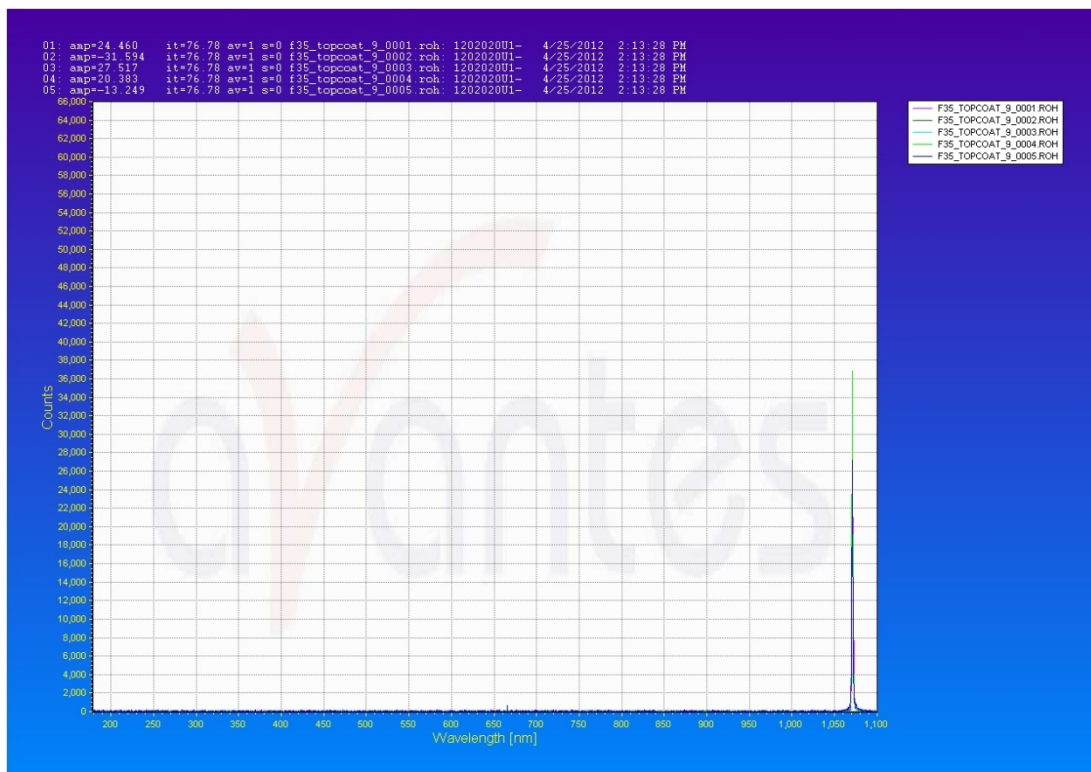
A comparison of Figures 21 and 22 show that at the minimum power level (540W), a significant difference in signal amplitude exists at 1070nm between the primer and topcoat. A comparison of Figures 23 and 24 shows that, at 6000W, a difference in signal amplitude exists not only at 1070nm, but in the region of 500 to 800nm as well. It is possible that these differences can be used in a control scheme to effectively remove the topcoat, while leaving the Deft 098 primer intact thus meeting Goal #2.

Figure 21. Primer Response at 540W (9% Laser Power)

Figure 22. Topcoat Response at 540W (9% Laser Power)

Figure 23. Primer Response at 6000W (100% Laser Power)

Figure 24. Topcoat Response at 6000W (100% Laser Power)

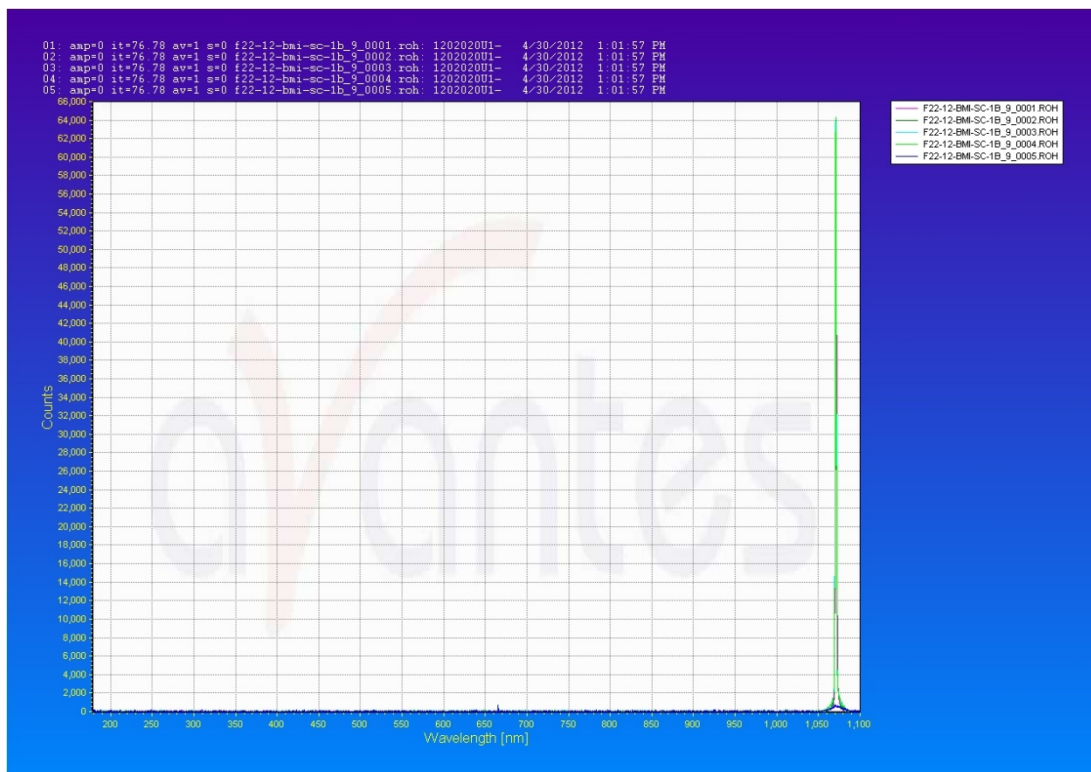
When comparing Figures 25-28, it is easy to see that there is no appreciable difference in spectral response between the base primer and conductive layers at either power level. It is unlikely that spectral sensors will be useful in accomplishing the goal of removing all layers down to the base primer (Goal #1).

Figure 25. Base Primer Response at 540W (9% Laser Power)

Figure 26. Conductive Layer Response at 540W (9% Laser Power)

Figure 27. Base Primer Response at 6000W (100% Laser Power)

Figure 28. Conductive Layer Response at 6000W (100% Laser Power)

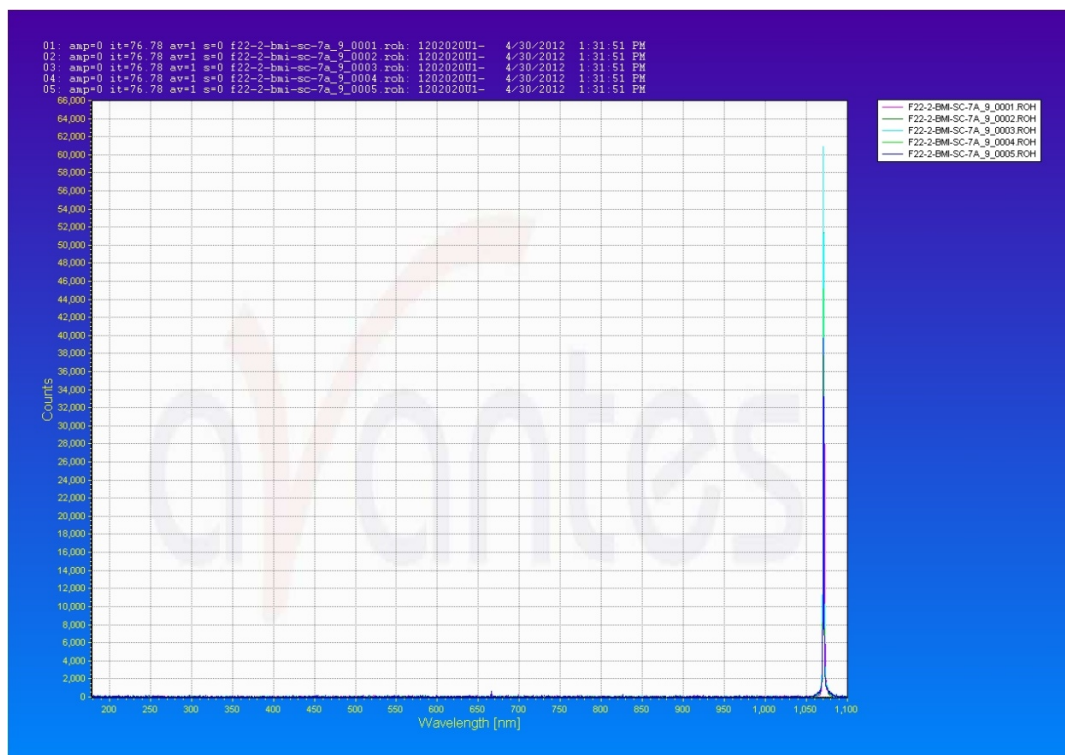
In order to accomplish Goal #2, a difference in spectral response must be seen between the PR-1829 Adhesive and the intermediate primer layer. Figures 29 through 32 document the spectral responses of these coatings at laser power levels of 540W (9%) and 6000W (100%).

Figure 29. Intermediate Primer Response at 540W (9% Laser Power)

Figure 30. Adhesive Layer Response at 540W (9% Laser Power)

Figure 31. Intermediate Primer Response at 6000W (100% Laser Power)

Figure 32. Adhesive Layer Response at 6000W (100% Laser Power)

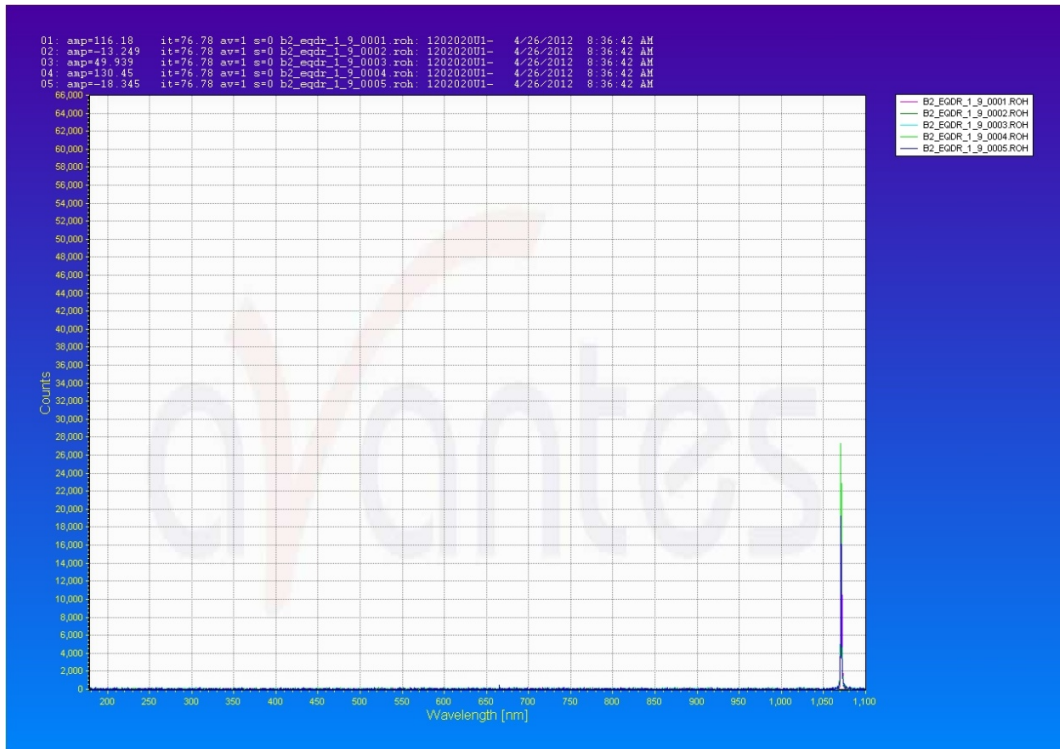
Figures 33 through 36 depict the spectral responses to be evaluated for Goal #1b where coating is laid on the base primer.

Figure 33. Base Primer Response at 540W (9% Laser Power)

Figure 34. Response at 540W (9% Laser Power)

Figure 35. Base Primer Response at 6000W (100% Laser Power)

Figure 36. Response at 6000W (100% Laser Power)

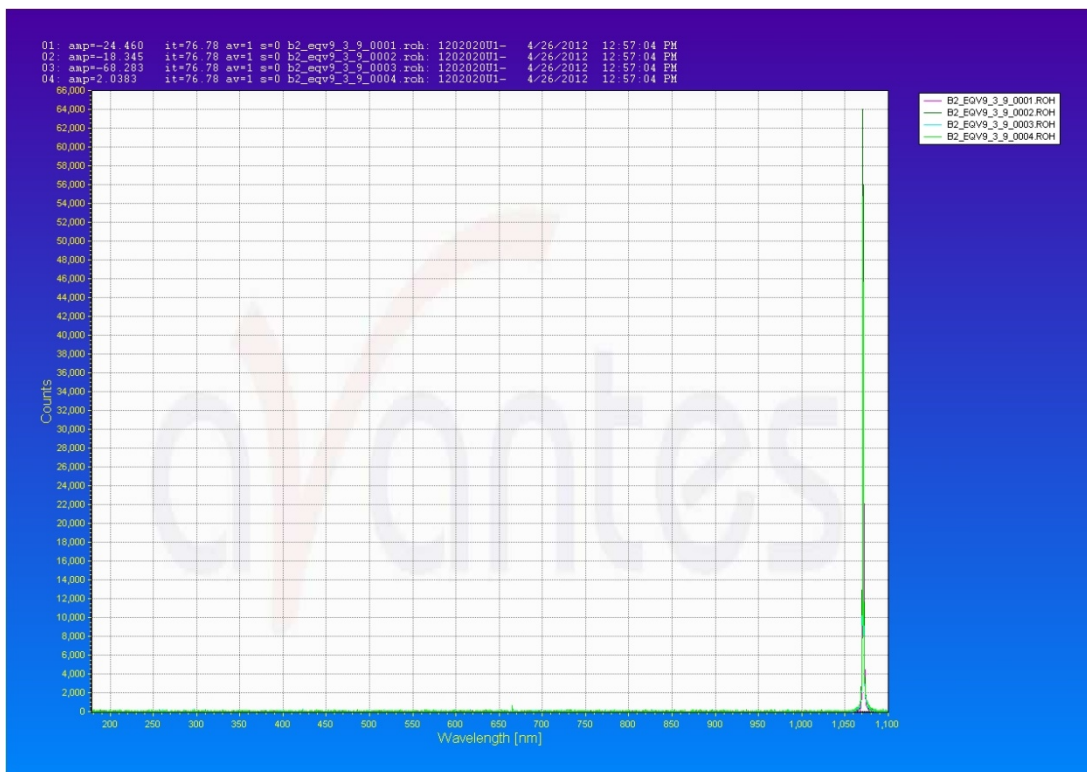
During spectral response testing, it was noted that the rain erosion stack-up was very sensitive to the fiber laser power and was easily damaged. Since the base primer layer is necessarily thin, it is doubtful that all coating layers could be removed without destroying the film. Therefore, CTC proposes that coatings in this particular stack-up be removed only to the base layer of primer in an attempt to prevent substrate damage (Goal #1b). To this end, Figures 37 through 38 show the spectral responses of the base primer and rain erosion coating at 540W (9% laser power) and 6000W (100% laser power). The Figures 39 and 40 are shown in order to see the comparisons more clearly.

Figure 37. Base Primer Response at 540W (9% Laser Power)

Figure 38. Rain Erosion Coating Response at 540W (9% Laser Power)

Figure 39. Base Primer Response at 6000W (100% Laser Power)

Figure 40. Rain Erosion Coating Response at 6000W (100% Laser Power)

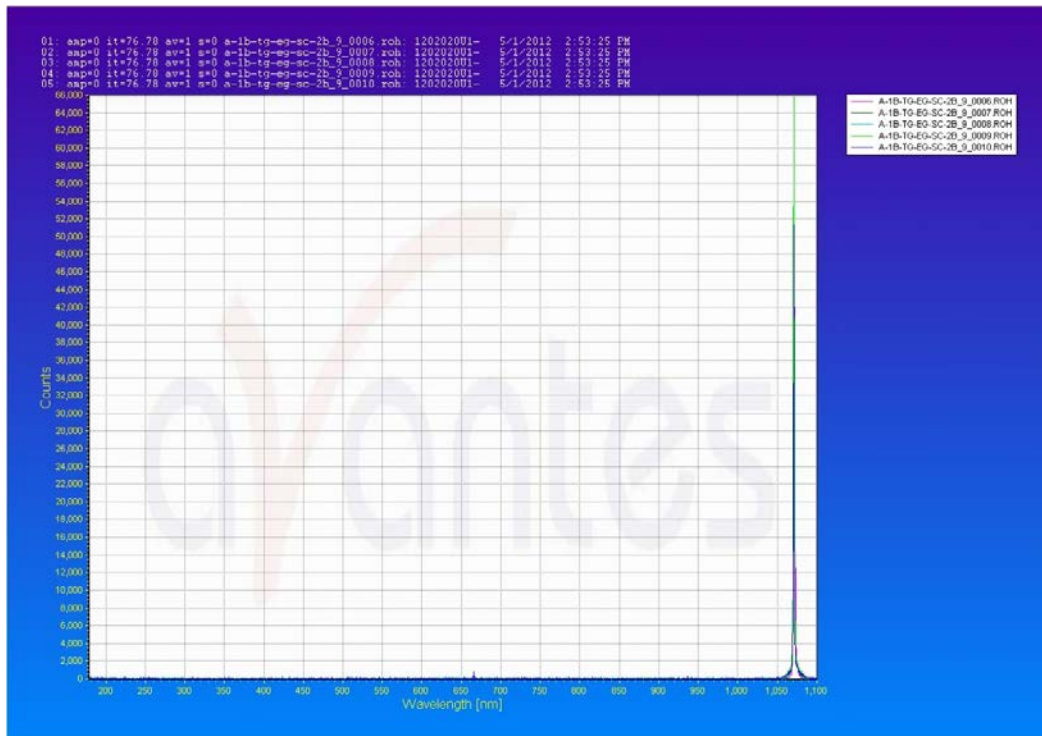
Figures 45 through 48 show the responses of the Upper Primer and Tan CARC coatings (sensory results in support of Goal #2).

Figure 45. Upper Primer Layer Response at 540W (9% Laser Power)

Figure 46. Tan CARC Response at 540W (9% Laser Power)

Figure 47. Upper Primer Layer Response at 6000W (100% Laser Power)

Figure 48. Tan CARC Response at 6000W (100% Laser Power)

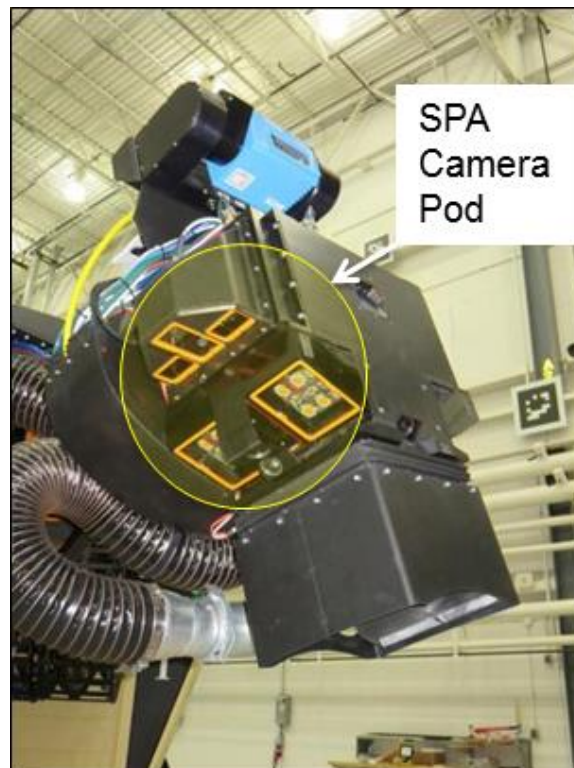
Figure 61. SPA Camera Pod on ARLCRS

The SPA sensor system is a color recognition sensor system that discriminates coatings prior to laser ablation by analyzing camera imagery with computer vision and machine learning techniques. The primary purpose of the SPA is to provide a classification and confidence level of the aircraft surface model. To accomplish this, multiple cameras, each with a different filter, and light emitting diode lights are used in a flexible design configuration, as shown in Figure 61, to allow the discrimination of surface coatings and substrate. The SPA system is a software-based system whose flexibility allows for adaption of new coating classes using machine-learning algorithms.

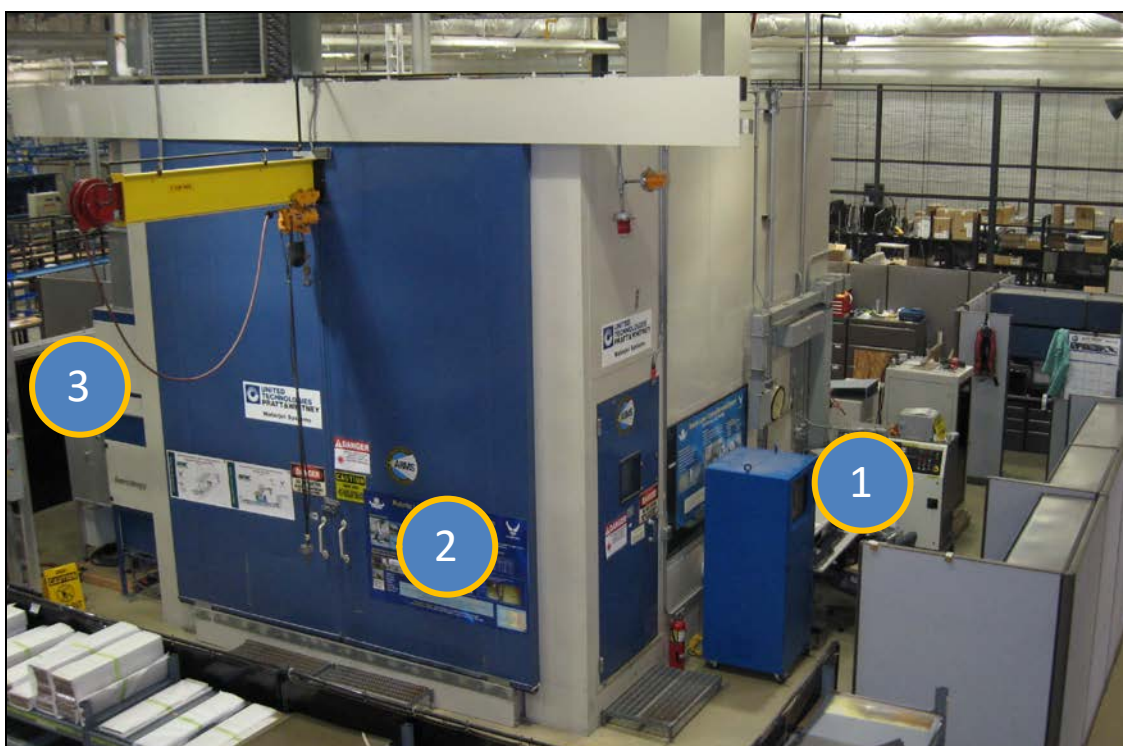
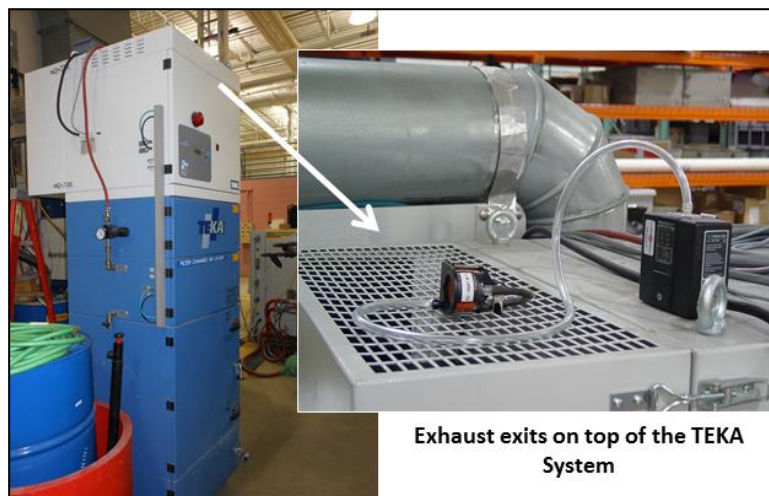
The air sampling was performed at three locations: (1) the fiber laser operator station, (2) inside the laser stripping cell (adjacent to the process) and (3) at the exhaust vent of the TEKA system, as shown in Figures 63 – 66.

Figure 63. Placement of Air Sampling Pumps

Figure 64. Air Sampling Location 1 – Operator Station

Figure 65. Air Sampling Location 2 – Inside Test Cell

Figure 66. Air Sampling Location 3 – TEKA Exhaust

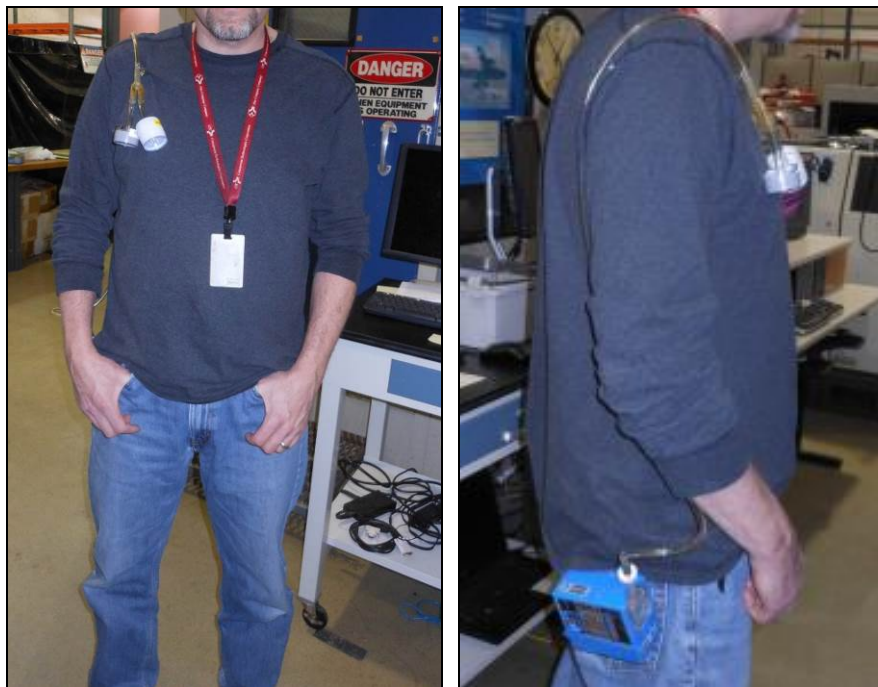
Figure 70. Personal Air Sample Located in the Operator's Breathing Zone

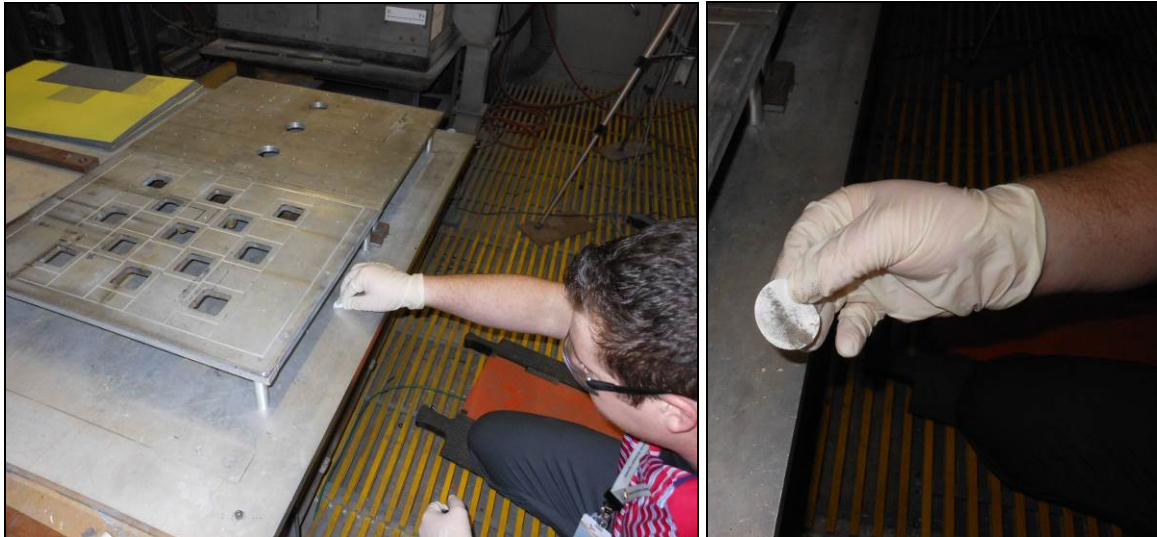
Figure 71. Baseline Wipe Sample Collected on Table Where Fiber Laser Stripping Process Occurs

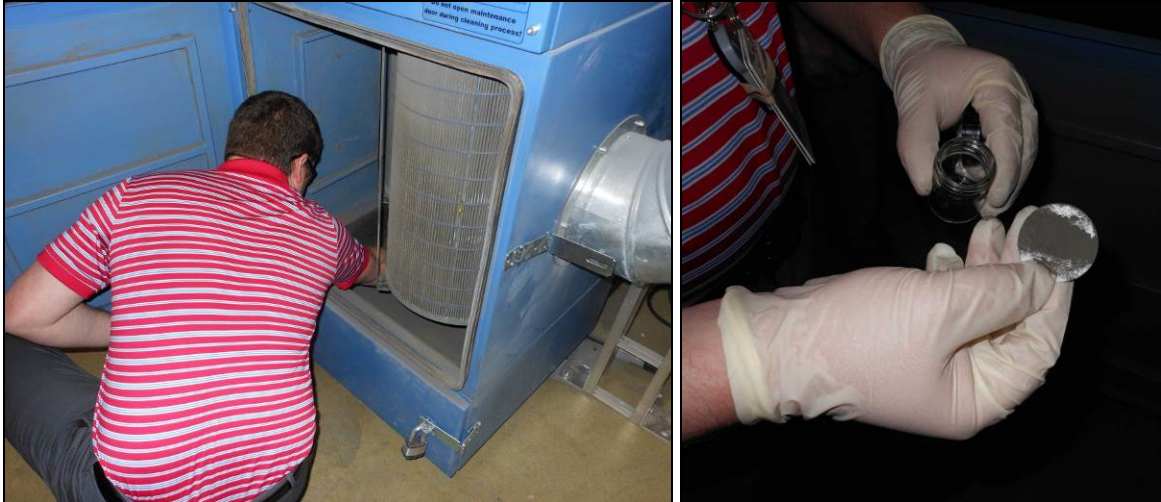
Figure 73. Wipe Sample Taken From TEKA Hopper after Laser Stripping
